HCEA Project No.: 16541B

FIELD REPORT

Date: November 21, 2019

Project Name: VIVA - White Oak

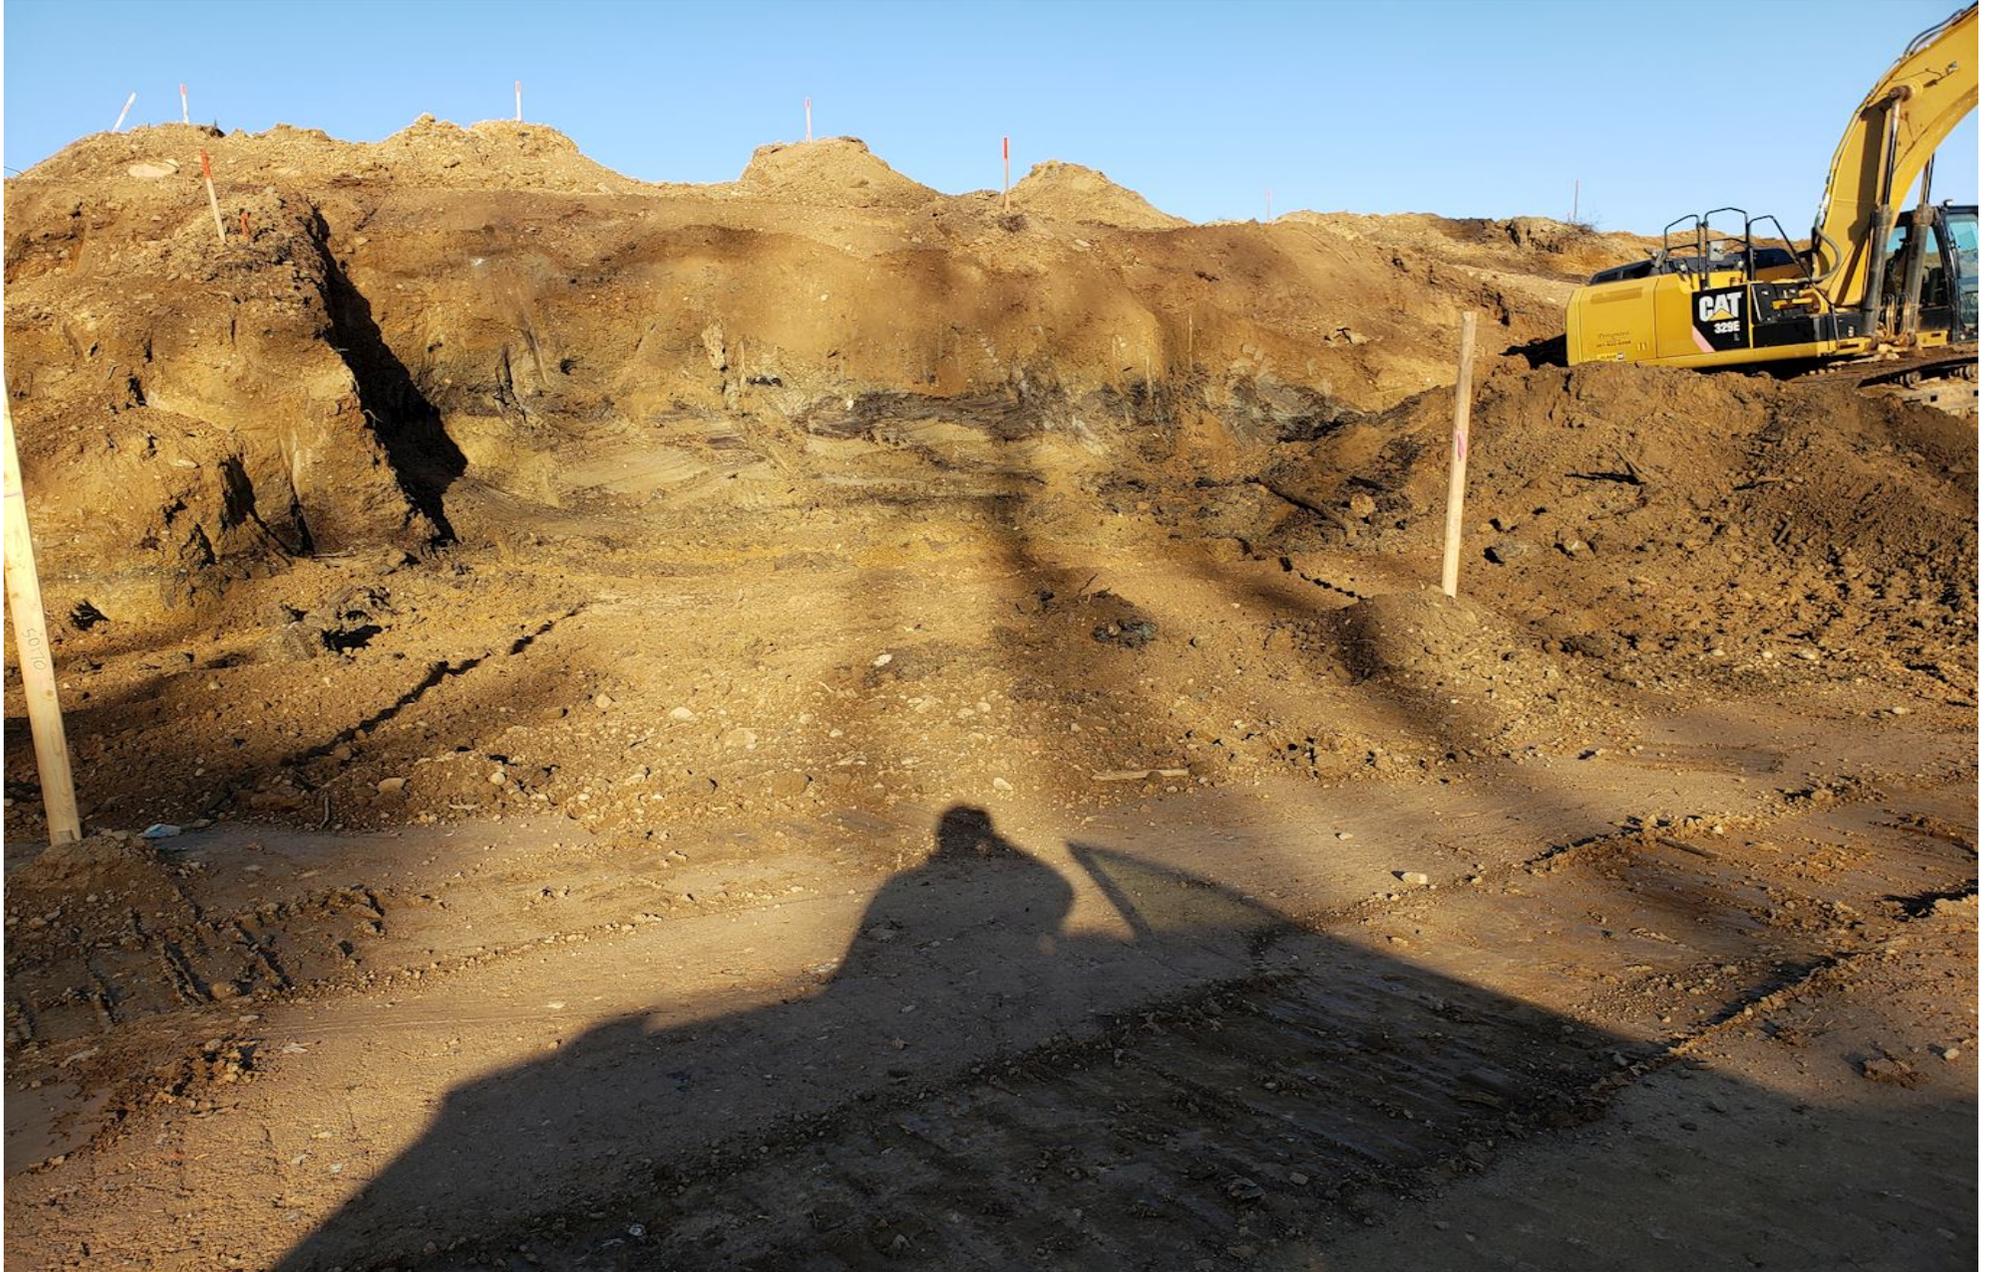
Writer discussed with Kenny (site superintendent with Percontee) the organic layer of material that continues under the cut slope. The line of organic material is 10 feet below in place fill material. Writer discussed via phone with HCEA project manager Dave Adkins & Chris Hillis. The organics can be addressed at later date with additional borings to determine foundation system required depending upon proposed structures to be built.
