**MARYLAND DEPARTMENT OF THE ENVIRONMENT**

**Surface Mine Inspection Field Report****Mine Inspector:** Alex Eiler**Permittee:** Percontee Inc.**Site Name:** McCeney Pit**Address of the Site:** FDA Boulevard, Silver Spring, MD 20904**County:** Montgomery**Contact Person:** Joe Horton, Felix AndrewAPPROVED:

DATE: 4/15/25**Permit Number:** 93-SP-0430**Expiration Date:** 09/30/2027**SCD Approval Expiration Date:** 11/19/27**NPDES Number:** MDG499863**Inspection Date:** 04/03/2025**Type of Inspection:** Periodic**Site Status:** Active**Site Condition:** Compliant**Approved Permit Acreage:** 144.0**Estimated Open Acres:**  $\approx 50$ **SITE EVALUATION**

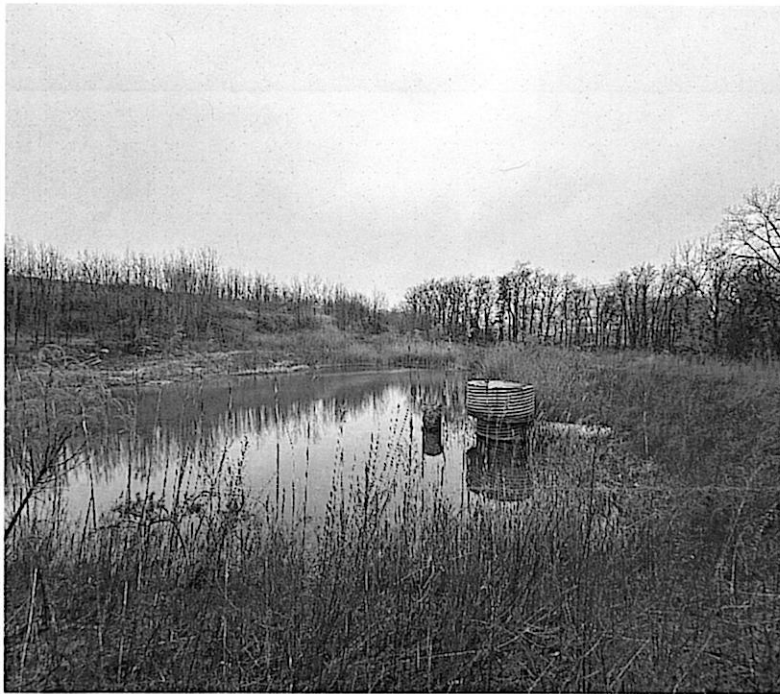
**Figure 6:** Sediment Basin No. 6.

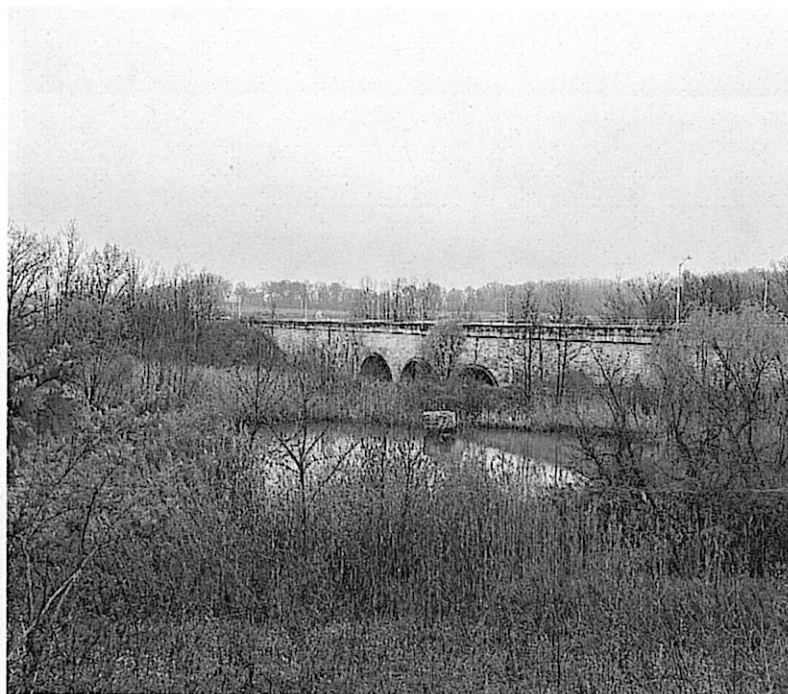
**Figure 7:** Sediment Basin No. 2.

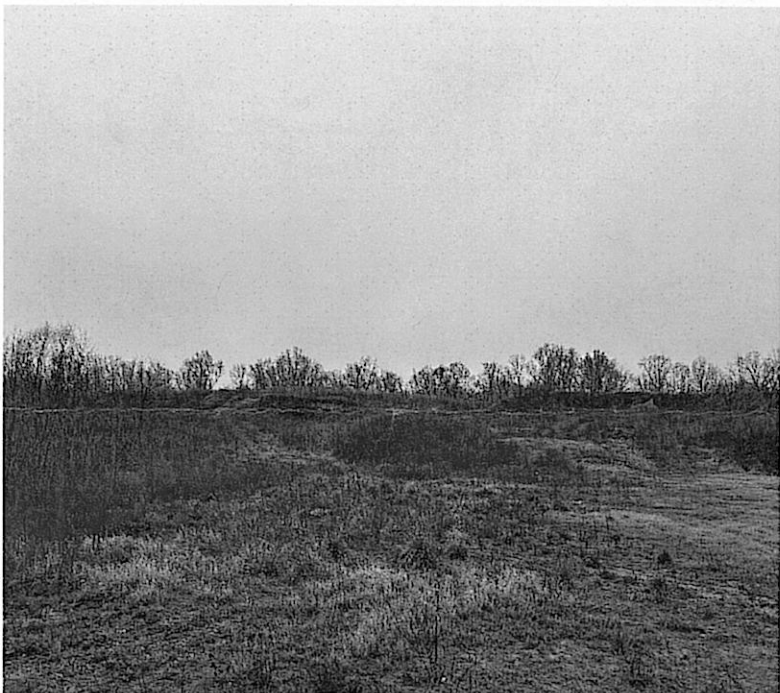
**Figure 8:** Site overview facing north.

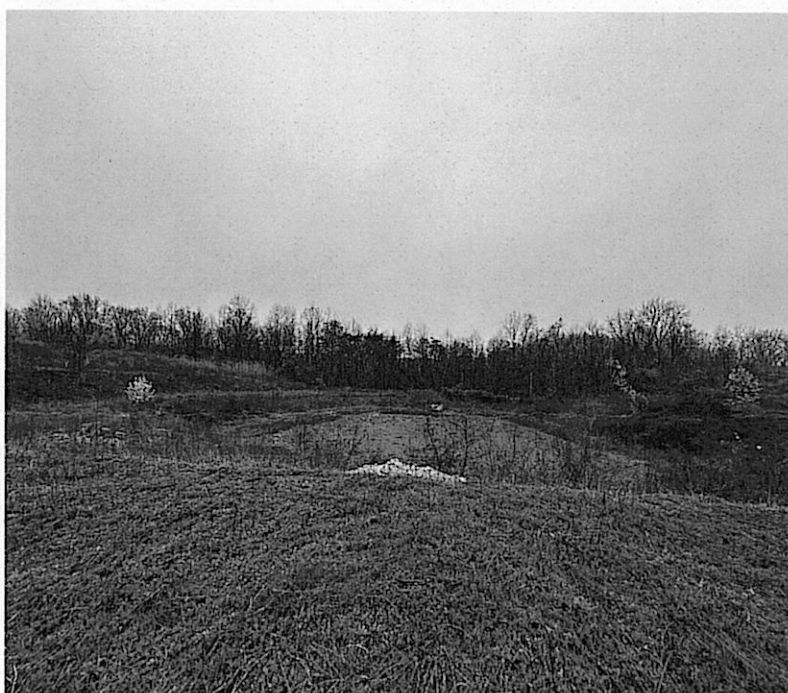
**Figure 9:** Sediment Basin No. 5.

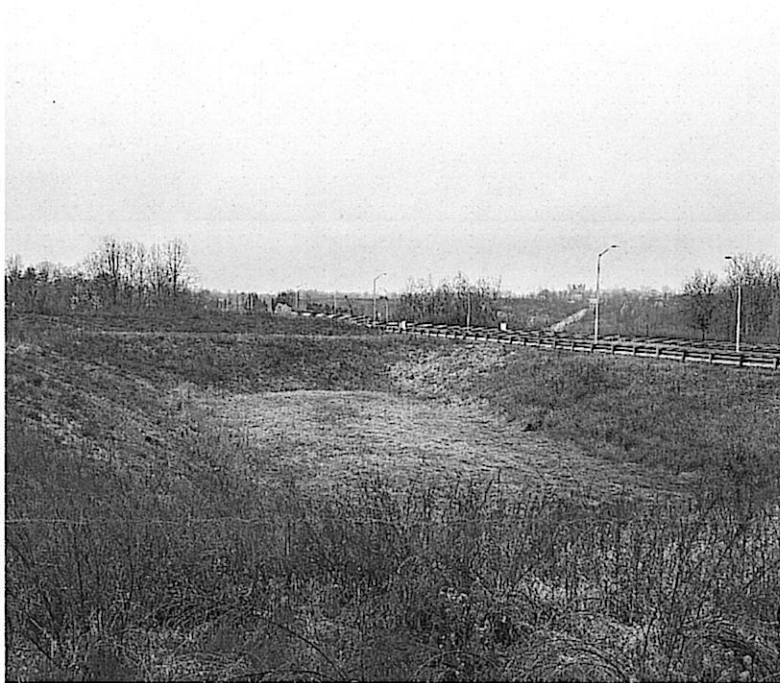
**Figure 14:** Sediment trap south side of FDA Blvd.

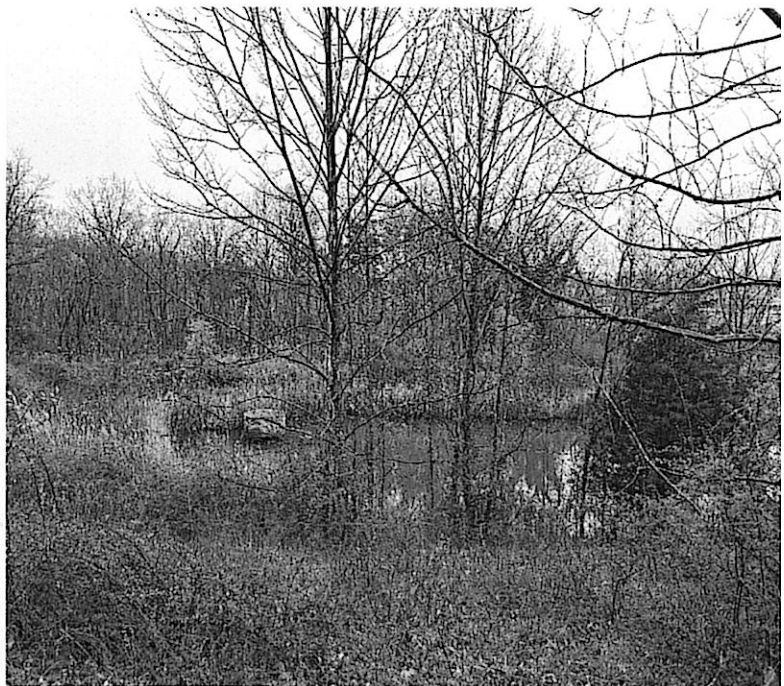
**Figure 15:** Sediment Basin No. 3.

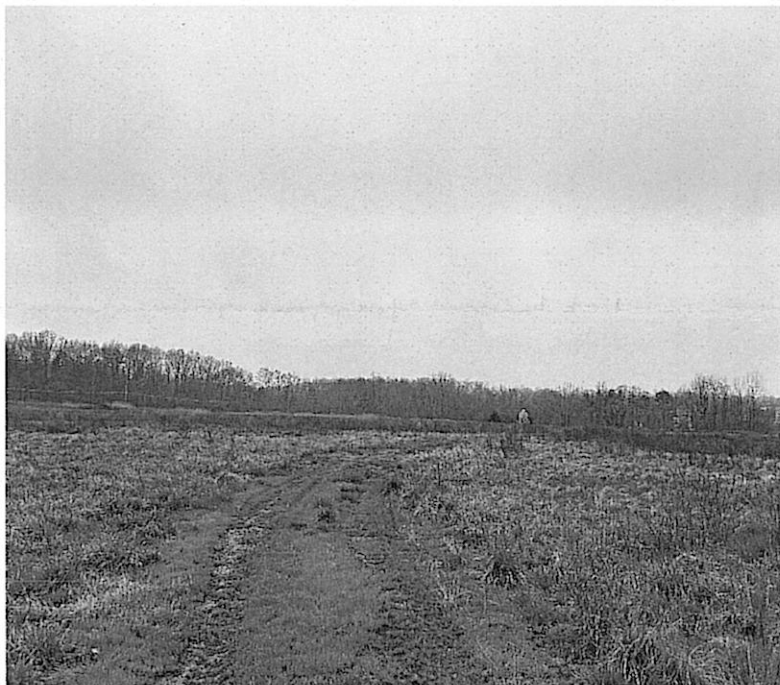
**Figure 16:** South site overview facing west.

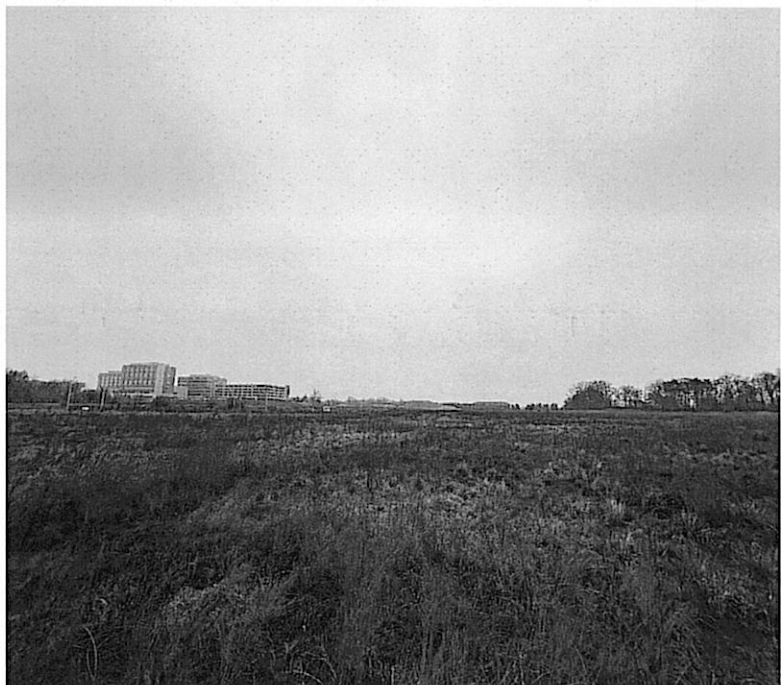
**Figure 17:** South site overview facing north.

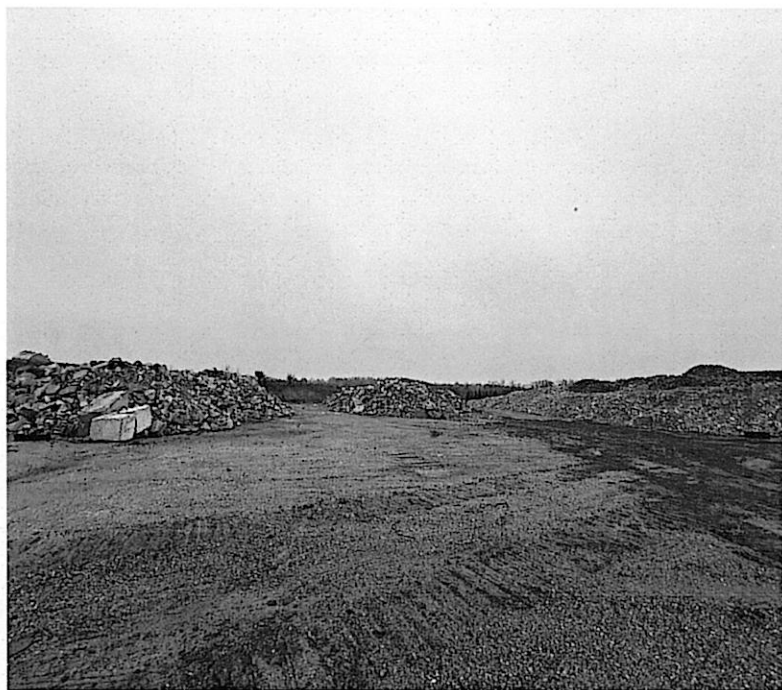
**Figure 10:** Recycled concrete stockpile.

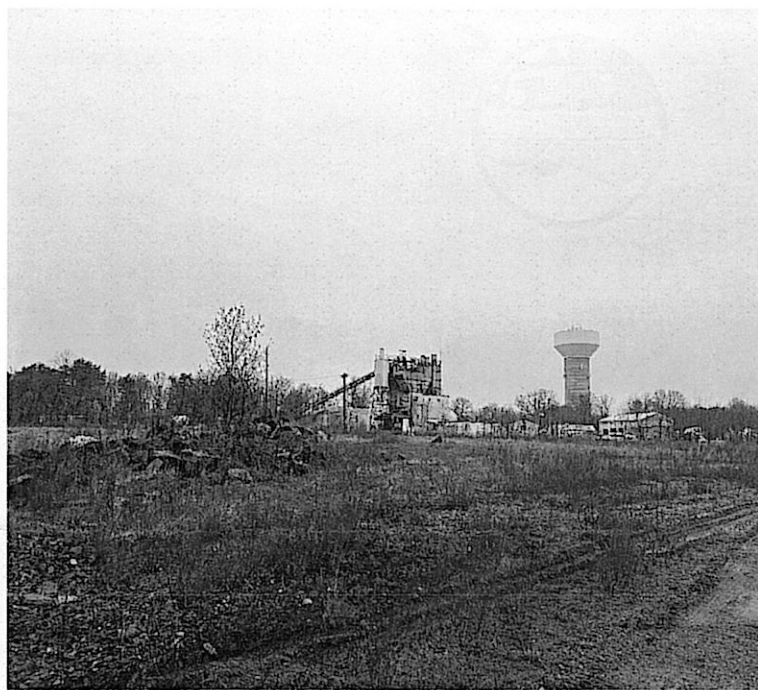
**Figure 11:** Overview facing north. Concrete plant in view.

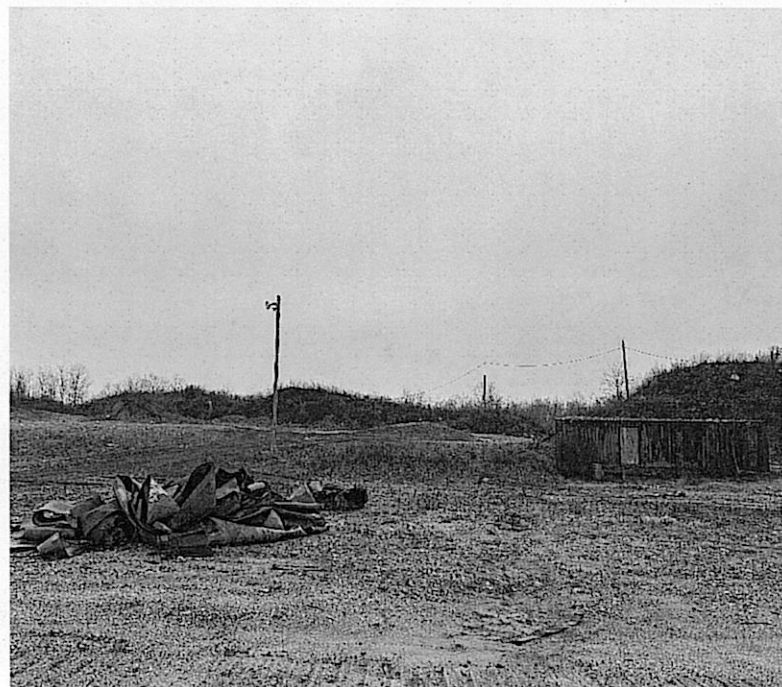
**Figure 12:** Waste material to be removed before reclamation.

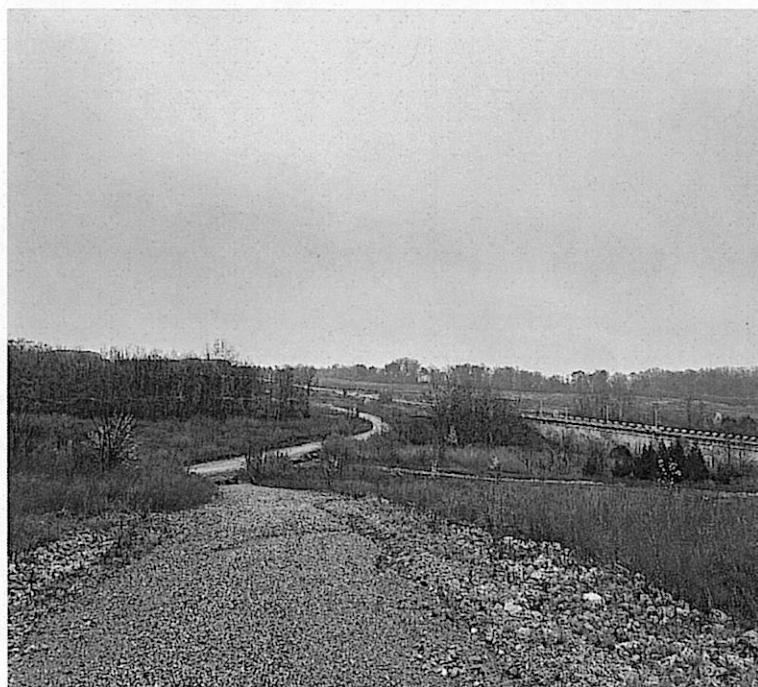
**Figure 13:** Site overview facing Southeast toward FDA Blvd.

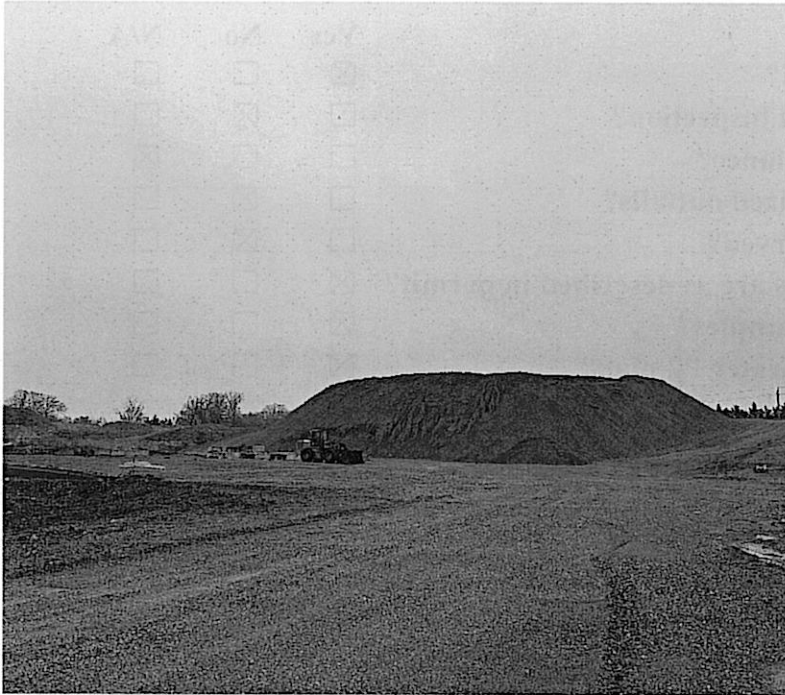
**Figure 2:** Product stockpile along Cherry Hill Road.

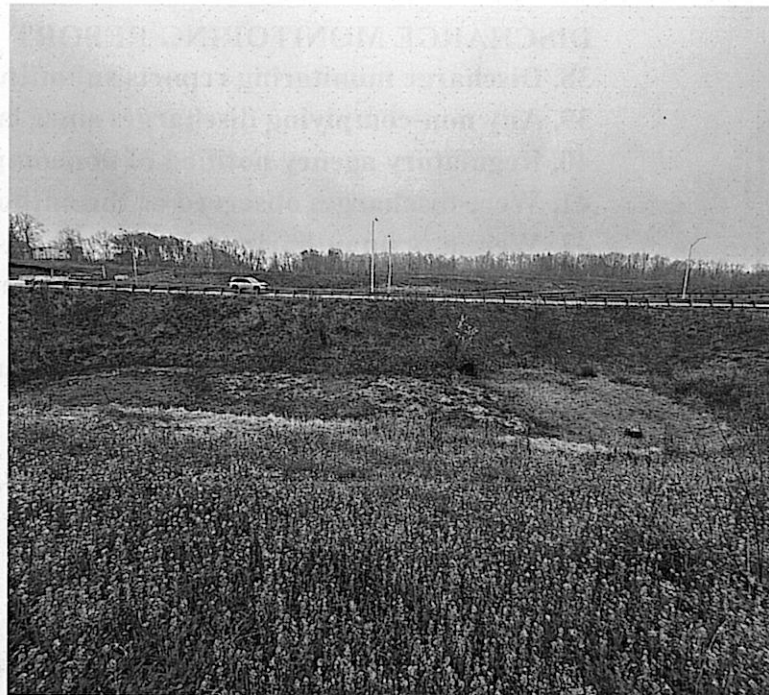
**Figure 3:** Sediment Trap along FDA Blvd.

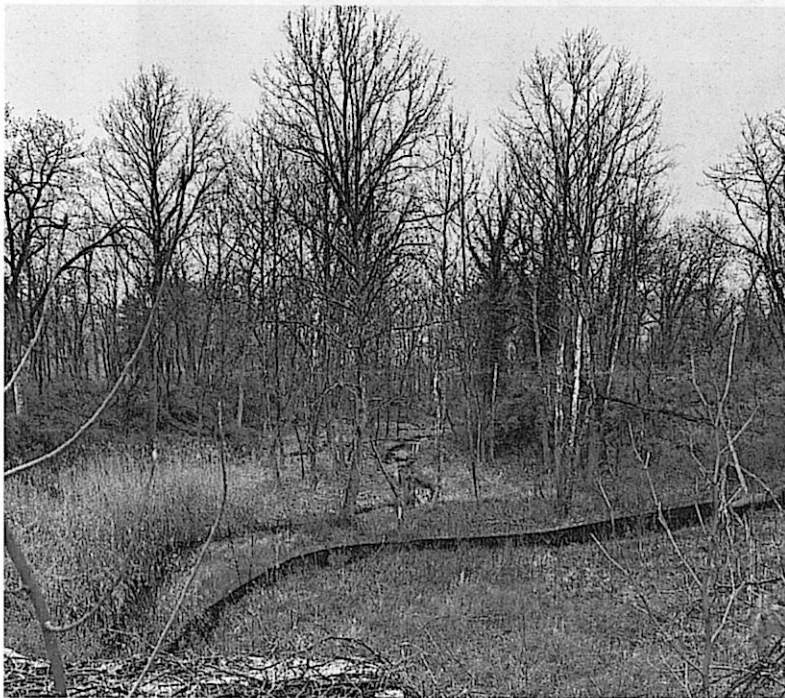
**Figure 4:** Unnamed tributary of the Paint Branch and floodplain.

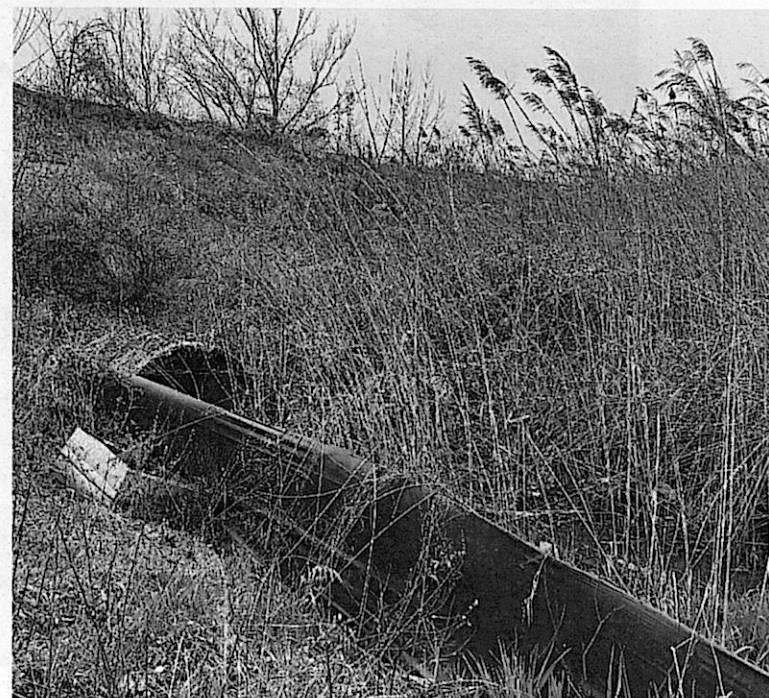
**Figure 5:** Double culvert stream crossing.
