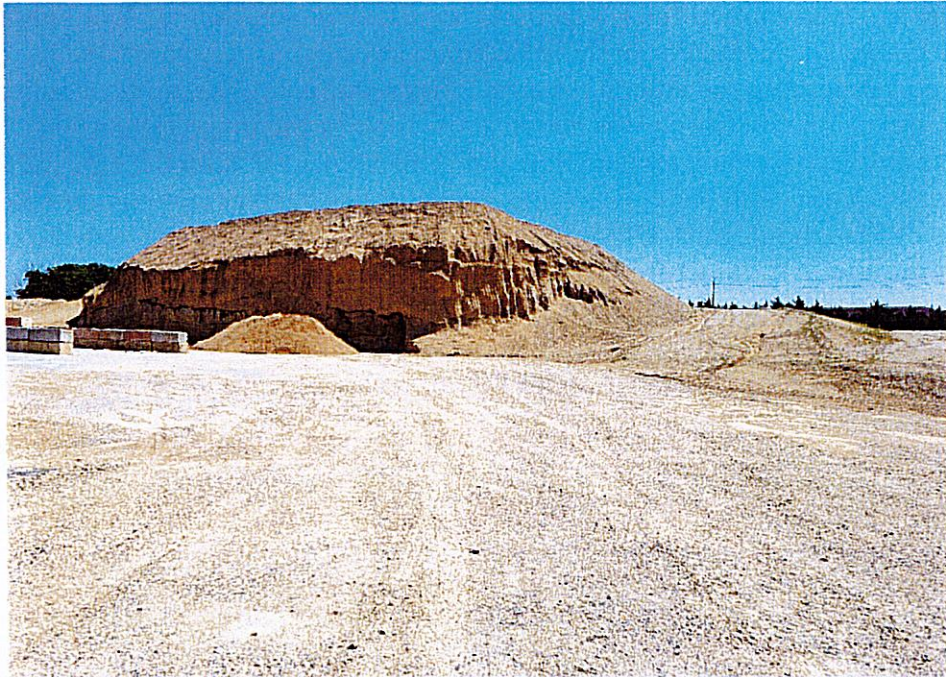
Figure 2: Stockpiled concrete material

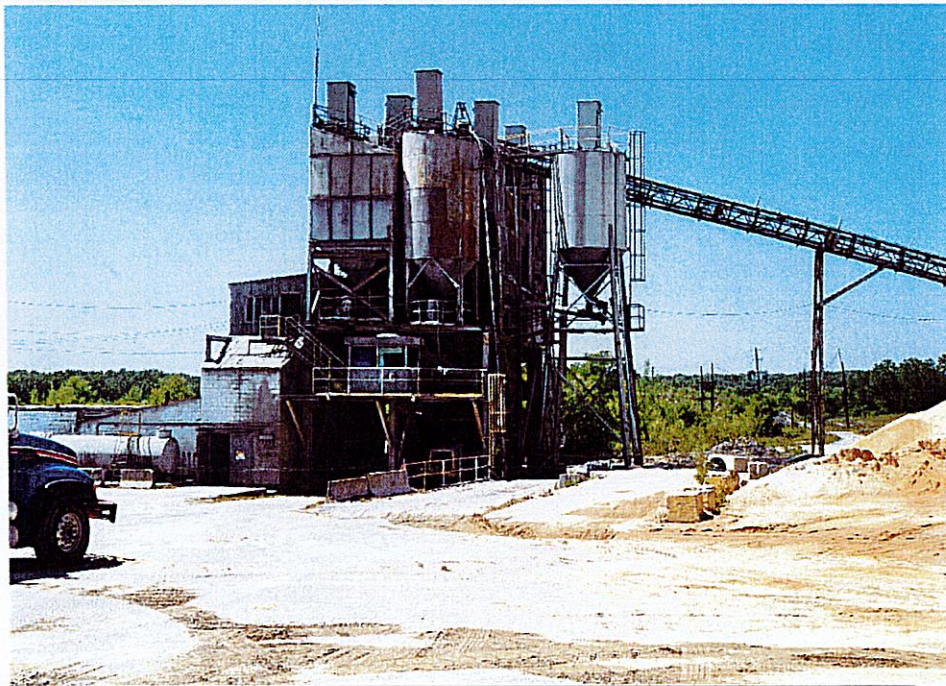
Figure 3: Active concrete plant

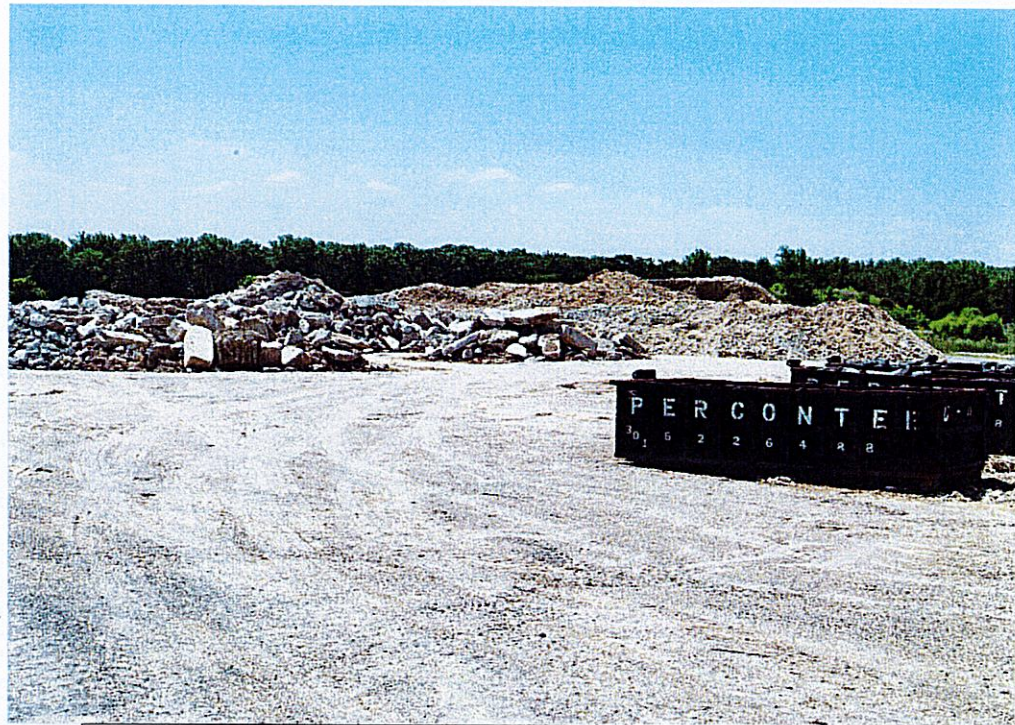
Figure 4: Stockpiled material west of plant

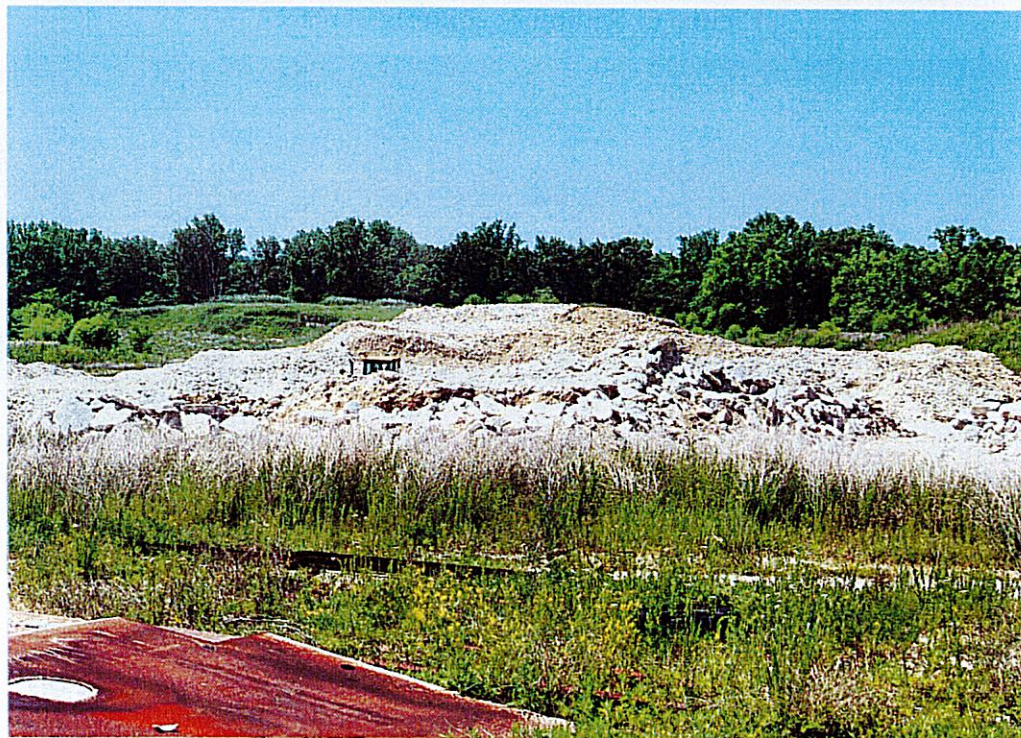
Figure 5: Reclamation underway to the Southwest

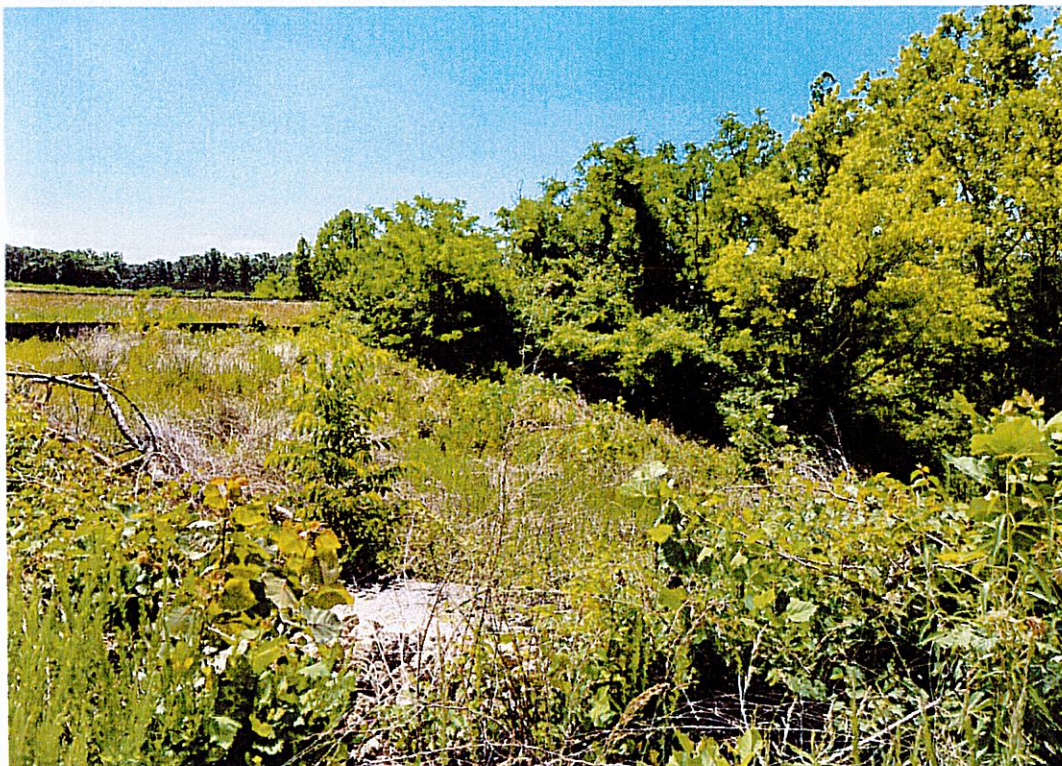
Figure 6: Sediment controls in place

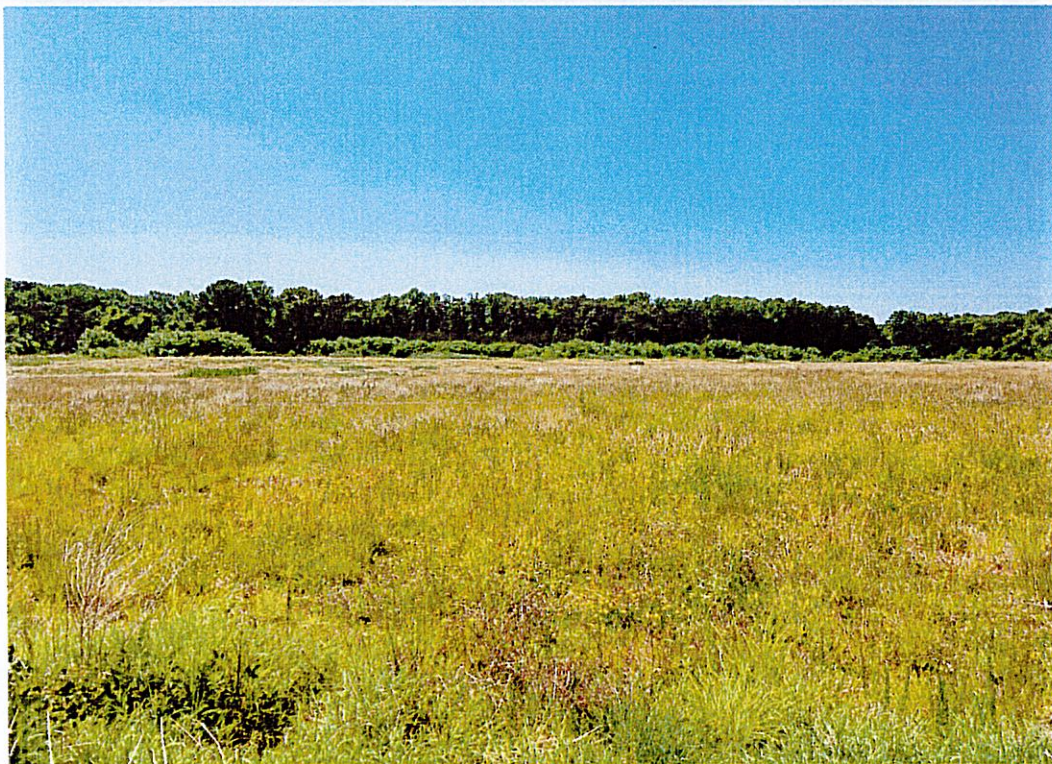
Figure 7: Reclamation nearly complete South of FDA Blvd
