MARYLAND DEPARTMENT OF THE ENVIRONMENT

Land and Materials Administration Mining Program

1800 Washington Boulevard Ste. 655, Baltimore, Maryland 21230 410-537-3557	X	re I	10/
Surface Mine Inspection Field Repo	<u>rt</u>		
Mine Inspector: Charles Chambers Permittee: Percontee Inc. Site Name: McCeney Pit	AP.	PROVE	ED: <u></u>
Address of the Site: 11900 Tech Road, Silver Spring, MD 20904 County: Montgomery Contact Person: Joe Horton	DA	TE:	9 13
Permit Number: 93-SP-0430 Expiration Date: 09/30/2027 SCD Approval Expiration Date: 09/29/2027 NPDES Number: MDG499863	7		
Inspection Date: 09/07/2023 Type of Inspection: Periodic Site Status: Active Site Condition: Compliant			
Approved Permit Acreage: 144.0 Estimated Open Acres: ≈ 50 SITE EVALUATION			
<i>Notes:</i> During the inspection, notable dust track out was seen at the site entrance Boulevard.	on FD	A	
REQUIRED ACTIONS Maintain a clean site entrance to provent mud and dust track out on the	o FDA	Rlvd	
 Maintain a clean site entrance to prevent mud and dust track out on the MINING PLAN AND SEDIMENT CONTROLS Was the permittee actively mining during the inspection? Does there appear to have been any activity since the last inspection? W

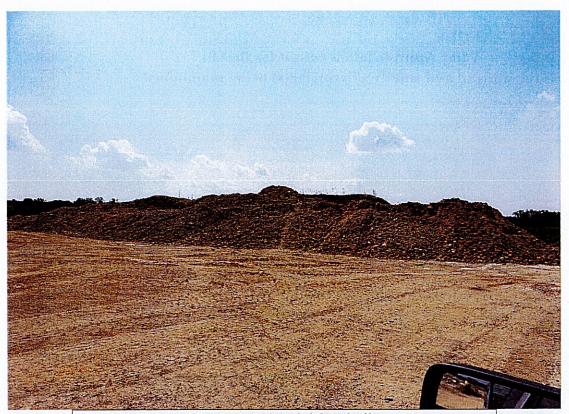
Figure 2: Material Stockpile

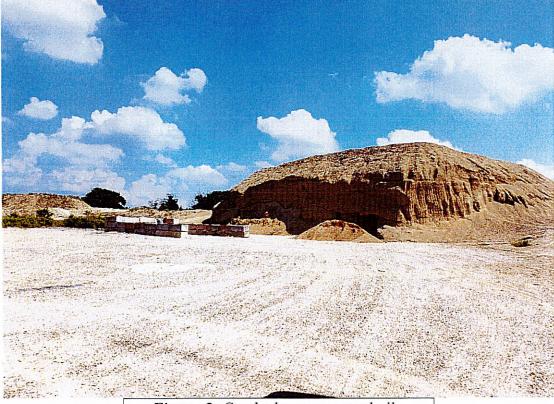
Figure 3: Crushed concrete stockpile

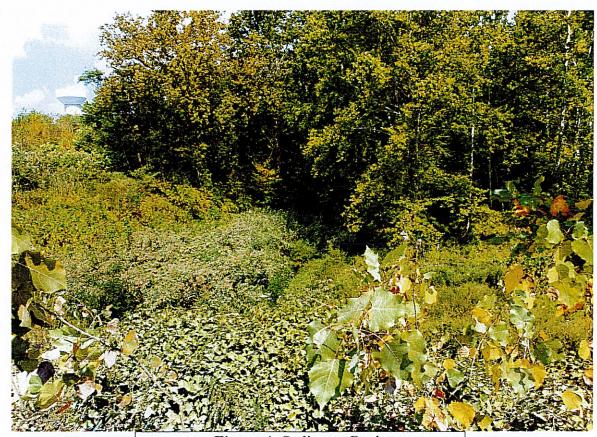
Figure 4: Sediment Basin

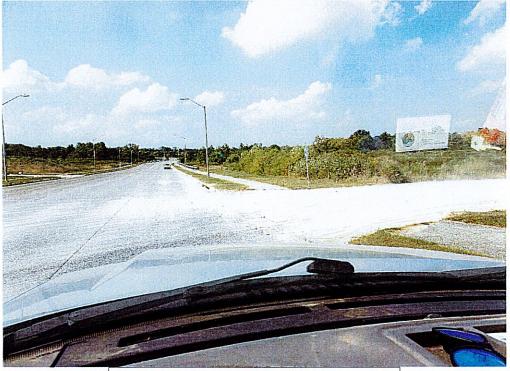
Figure 5: Dust Track out
