**MARYLAND DEPARTMENT OF THE ENVIRONMENT**

Land and Materials Administration  
Mining Program

**Surface Mine Inspection Field Report****Mine Inspector:** Alex Eiler**Permittee:** Percontee Inc.**Site Name:** McCeney Pit**Address of the Site:** FDA Boulevard, Silver Spring, MD 20904**County:** Montgomery**Contact Person:** Joe Horton, Felix AndrewAPPROVED: DSDATE: 9/17/25**Permit Number:** 93-SP-0430**Expiration Date:** 09/30/2027**SCD Approval Expiration Date:** 11/19/27**NPDES Number:** MDG499863**Inspection Date:** 09/15/2025**Type of Inspection:** Periodic**Site Status:** Active**Site Condition:** **Compliant****Approved Permit Acreage:** 144.0**Estimated Open Acres:**  $\approx 50$ **SITE EVALUATION**

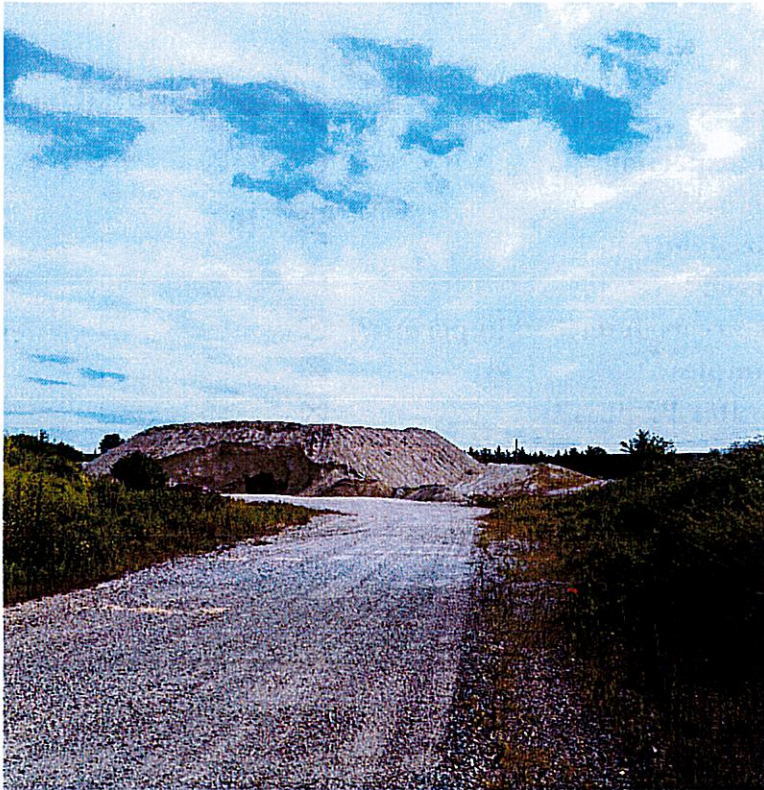
**Figure 2:** Product stockpile along Cherry Hill Road.

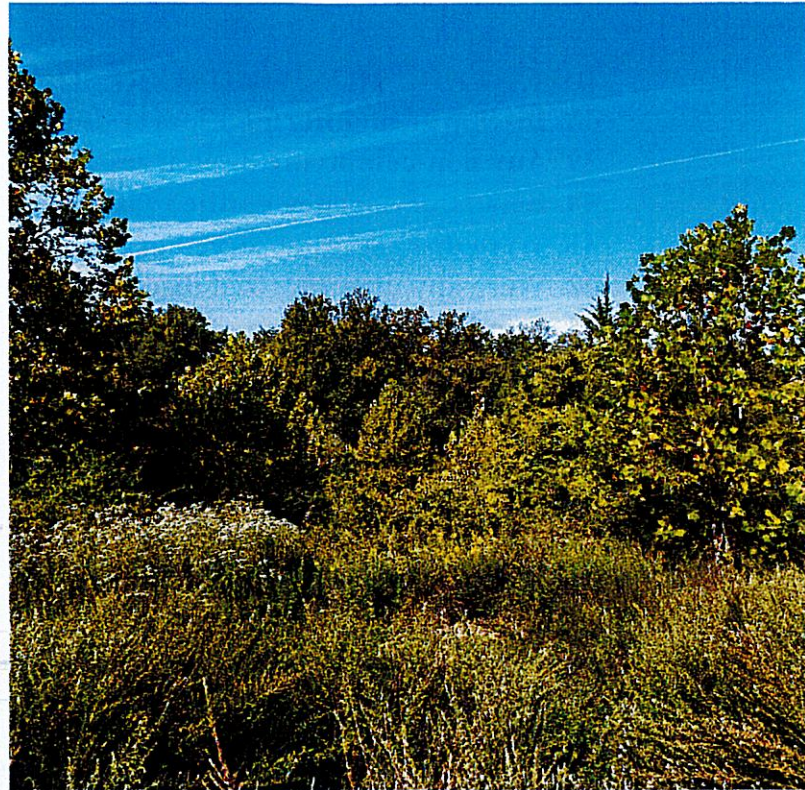
**Figure 3:** Sediment Basin No.3.

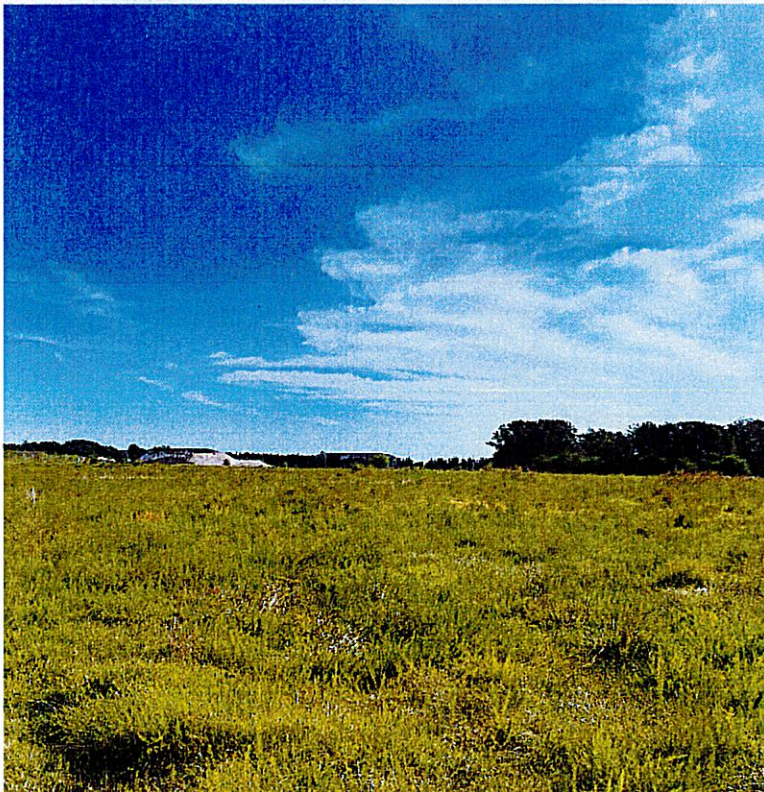
**Figure 4:** South side of permit area facing east.

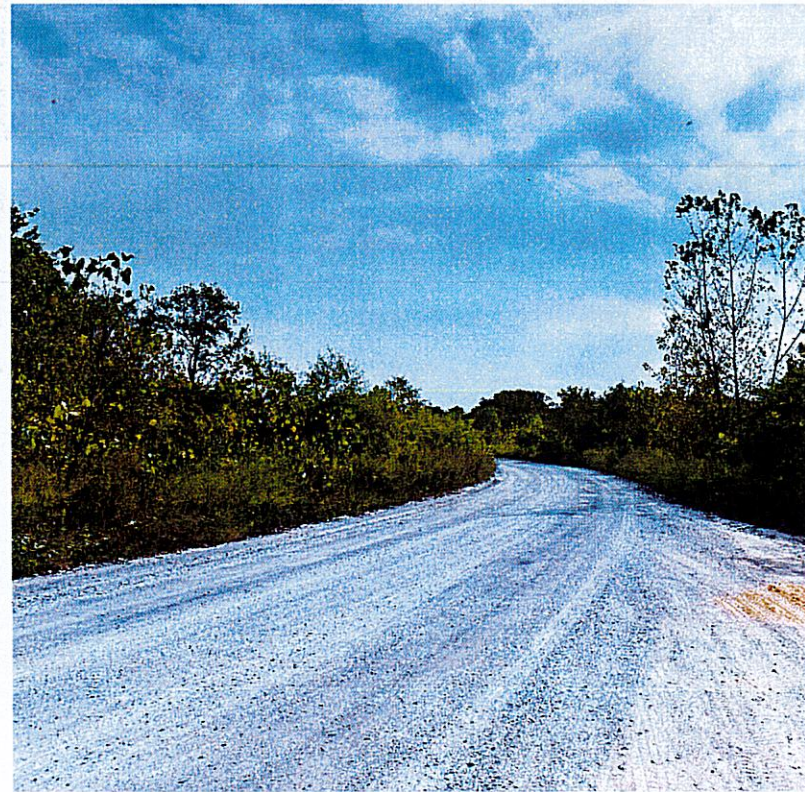
**Figure 5:** Haul road.

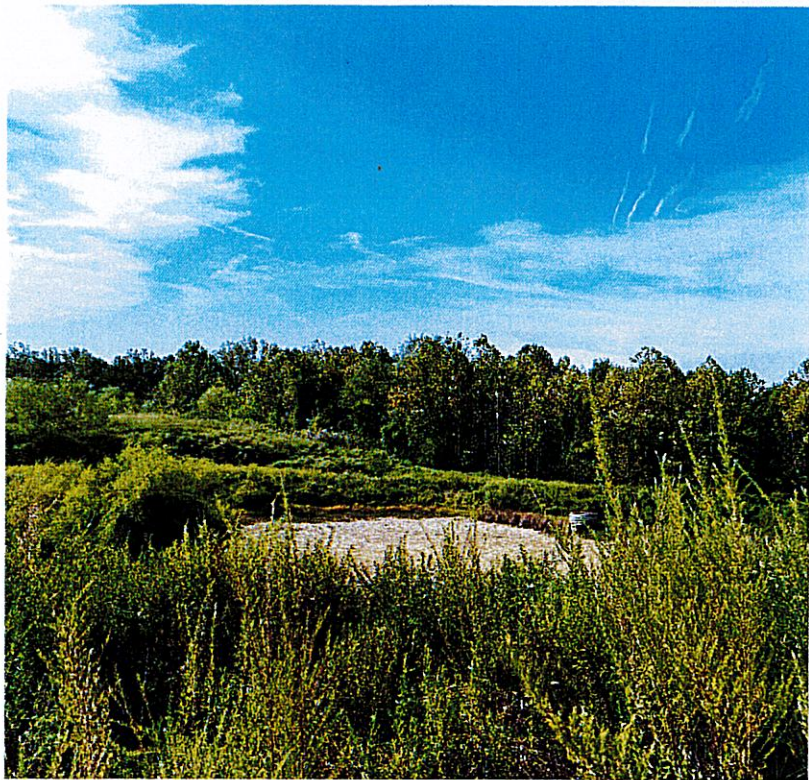
**Figure 6:** Sediment Basin No. 5.

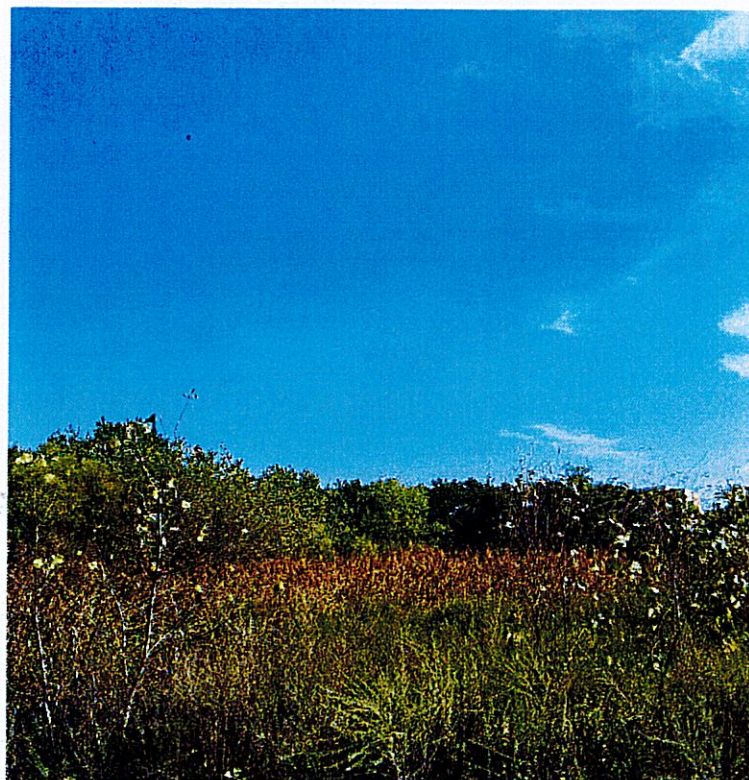
**Figure 7:** Sediment Basin No. 6.

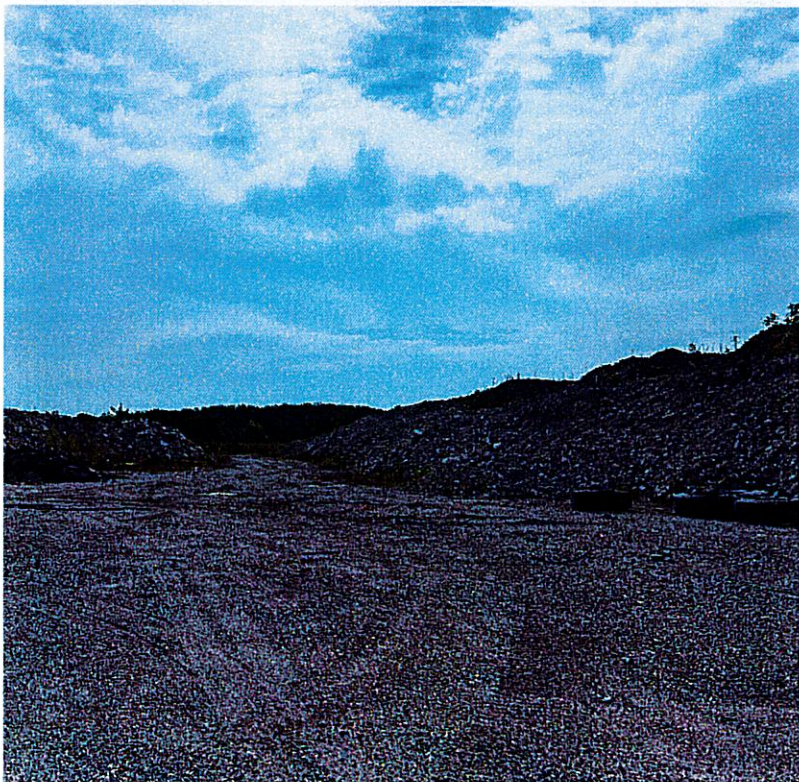
**Figure 8:** Stockpile. To be removed in reclamation.

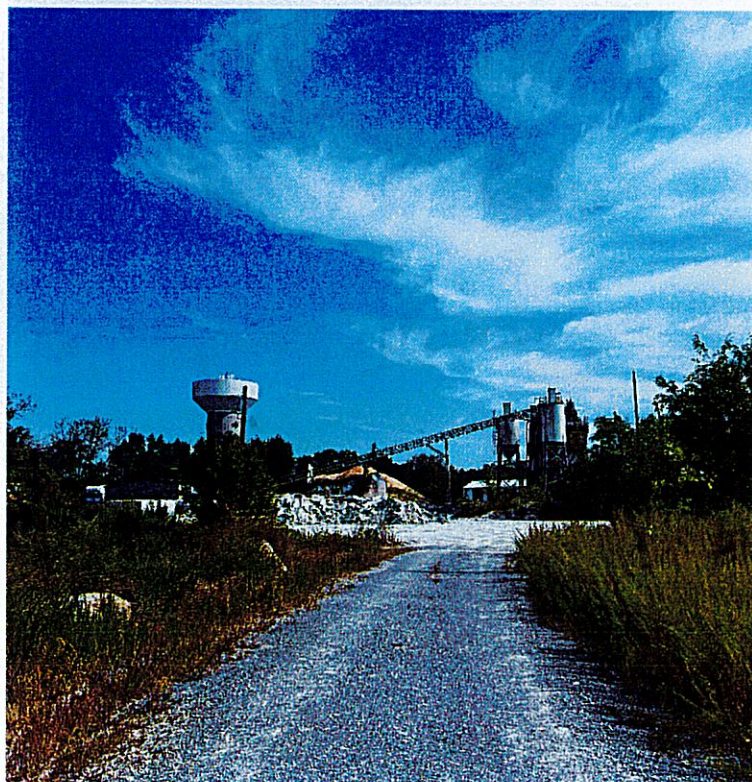
**Figure 9:** Concrete plant.

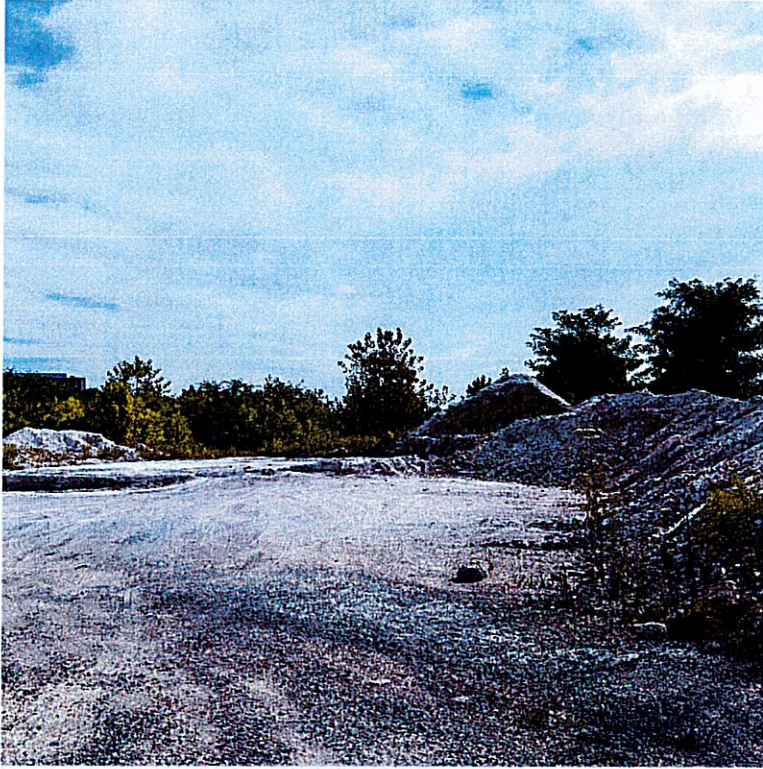
**Figure 10:** Concrete waste stockpile. To be removed in reclamation.

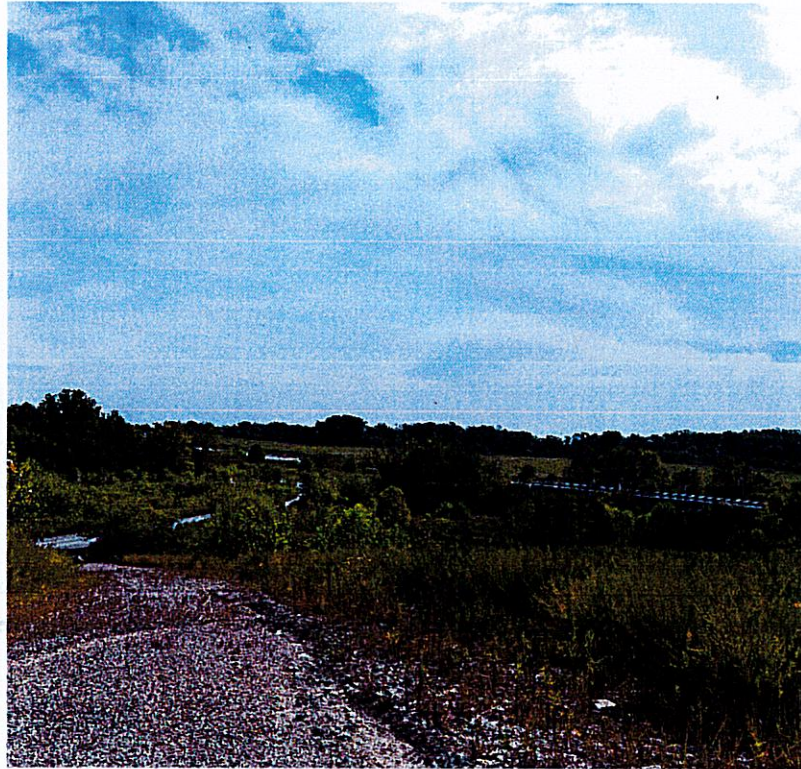
**Figure 11:** Overview facing east.

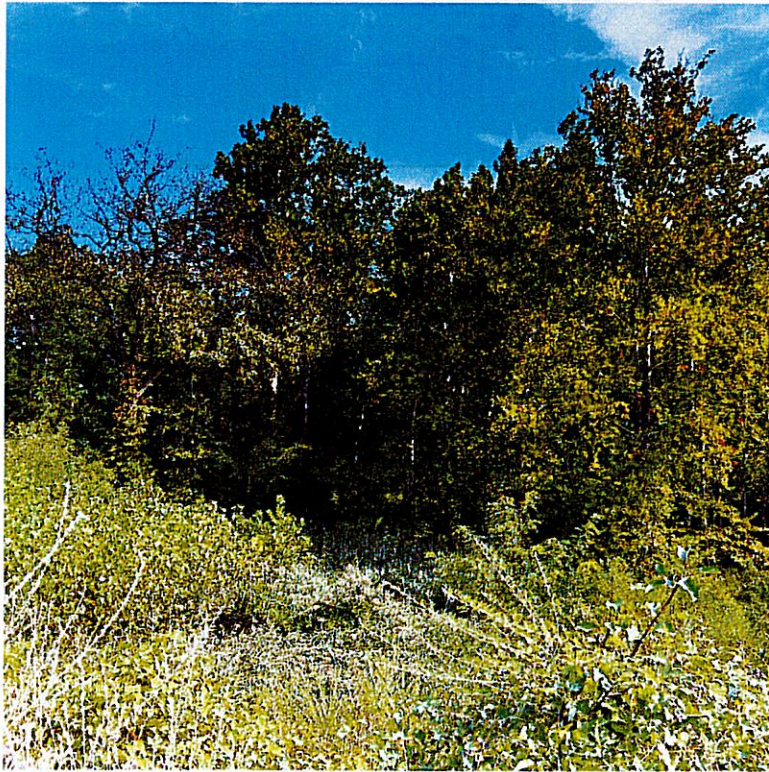
**Figure 12:** Stream crossing.

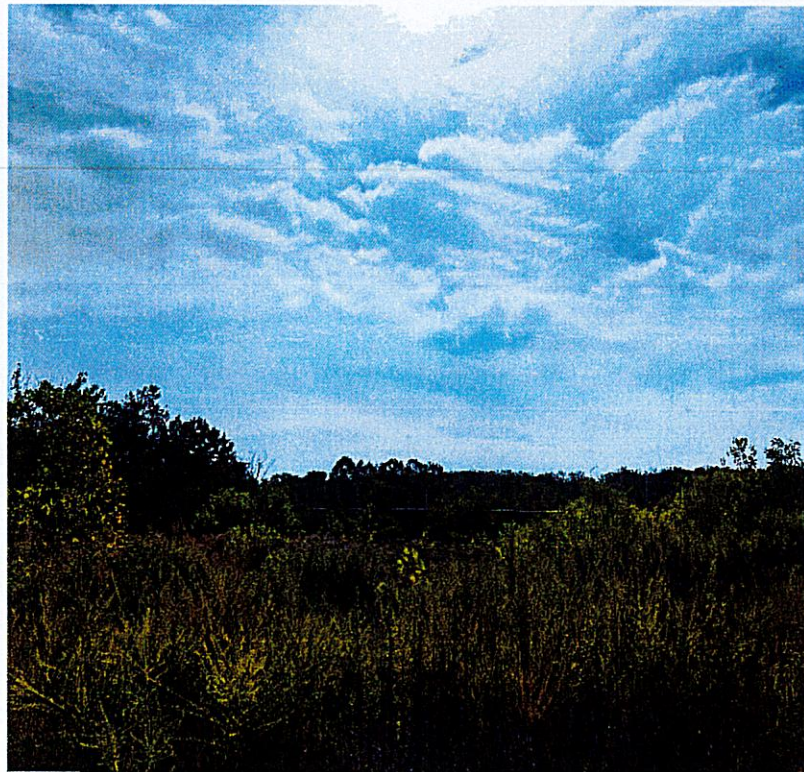
**Figure 13:** Sediment Basin No. 2.
